RESEARCH MEMORANDUM

PRELIMINARY INVESTIGATION OF ZIRCONIUM BORIDE CERAMALS
FOR GAS-TURBINE BLADE APPLICATIONS

By Charles A. Hoffman

NATIONAL ADVISORY COMMITTEE
FOR AERONAUTICS

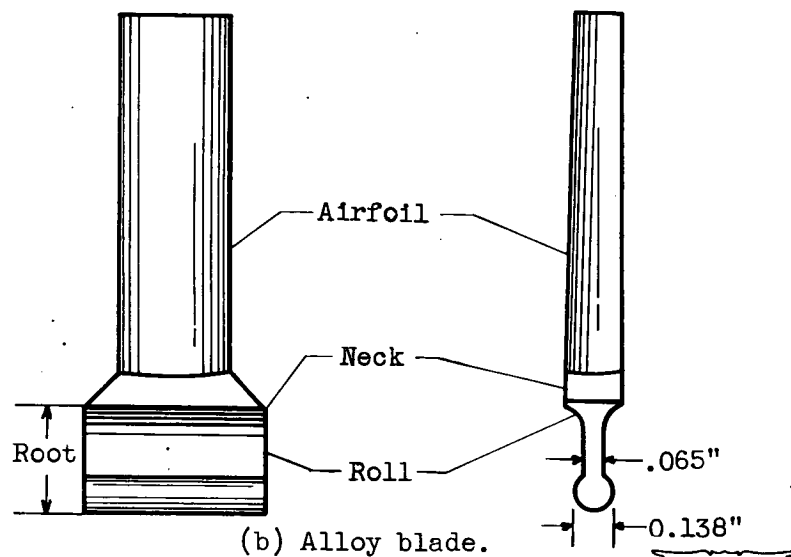
Figure 1. - Types of blade design used in investigation.

compensate for their brittleness. In addition, the roots of the ceramal blades were copper plated in order to achieve a better load distribution. However, these expedients were insufficient to prevent the failure of the ceramal blades at the neck-roll junction of the roots.

As stated previously, all the blades failed in the root and consequently the ability to withstand the severe conditions which exist at the midspan of the airfoil cannot be satisfactorily judged. Blade life could probably be prolonged by the use of improved root designs. When the ZrB_2 blades reported herein are compared with the TiC plus Co and TiC plus Ni blades reported in reference 3, it is seen that the ZrB_2 ceramal blades ran for shorter times under similar conditions than did the reference blades. However, in view of the facts that a very small number of ZrB_2 blades were investigated and that there is only limited experience in the fabrication of ZrB_2 blades, these results must be regarded as very preliminary.

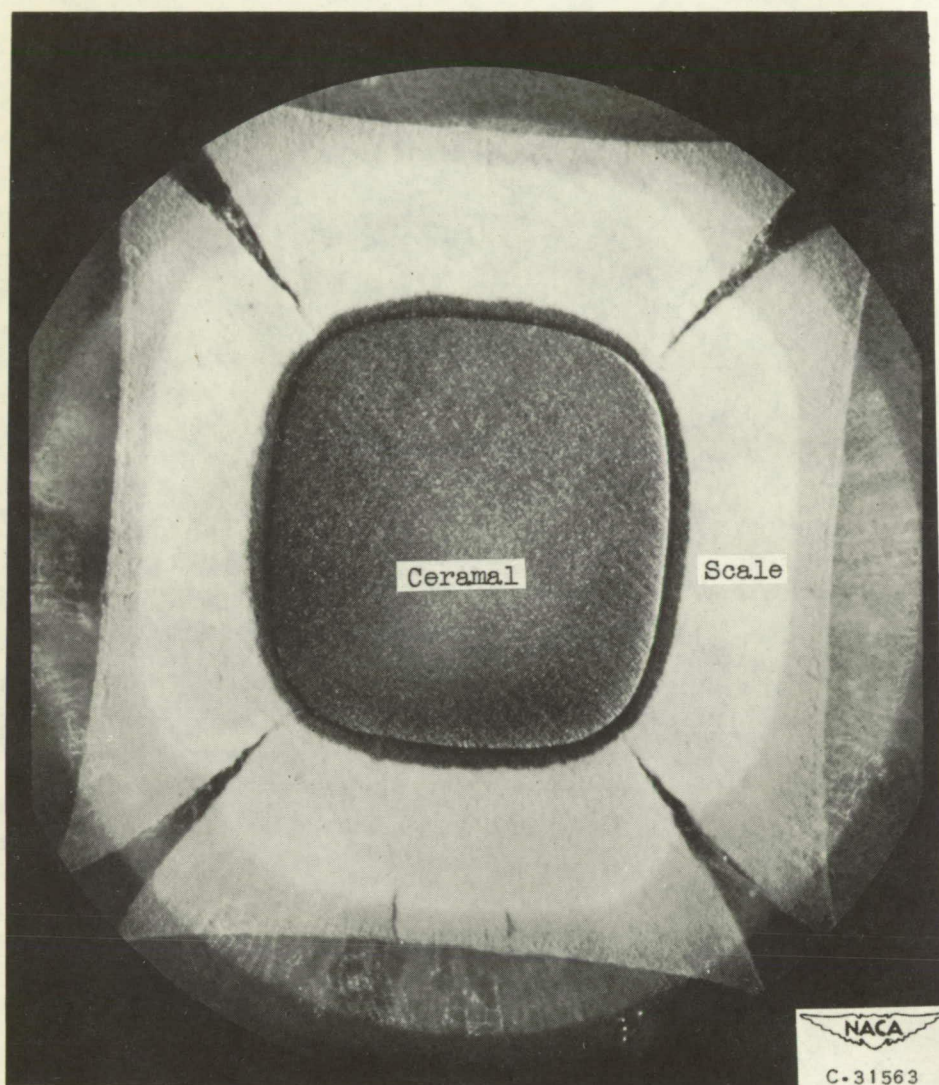
The 97.5 percent ZrB_2 plus 2.5 percent B specimen, which was kept at 2000° F for 100 hours, underwent serious oxidation, as illustrated in figure 4. A "Maltese cross" effect associated with oxidation occurring at the metal-scale interface is noted. Also to be noted is the occurrence of a number of zones within the scale. This specimen experienced a weight gain of 9.7 milligrams per square centimeter. Originally it had a cross-sectional area of 0.367 square centimeter and after heating had an unaffected area of 0.148 square centimeter, 60 percent of its original cross-sectional area having become oxidized. The X-ray diffraction study showed the scale to be composed only of ZrO_2 .

Figure 4. - Ceramal specimen containing 97.5 percent zirconium boride plus 2.5 percent boron (virgin powders) after 100 hours at 2000° F in air atmosphere. X15.
